The Wisconsin Early Mustangers

THE FEEDBAG October 20, 1985

SPEEDOMETER

System Diagnosis

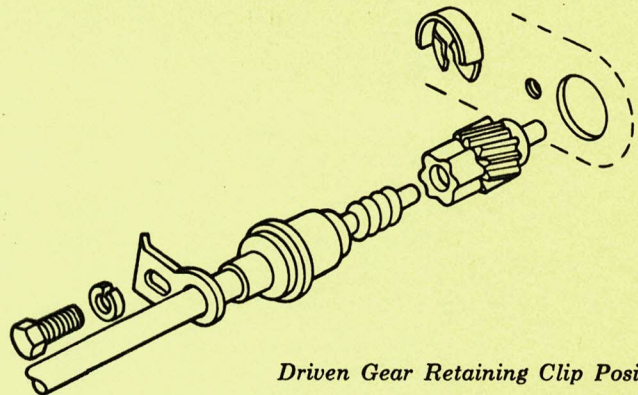
Driven Gear Retaining Clip Position

When diagnosing speedometer noise complaints that indicate a gear problem, the driven gear retaining clip position should be examined to confirm proper orientation. See illustration.

1. A scored, nicked, or gouged driven gear could indicate a defective drive gear. On those vehicles that have the drive gear integral with the transmission output shaft; the output shaft should be carefully inspected for imperfections and replaced if necessary.
